Hewlett Packard
Enterprise

MSM7xx Controllers and MSM Access Points Version 6.6.8.0 Release Notes

These release notes provide important release-related information for MSM software Version 6.6.8.0.

Part Number: 5200-4227
Published: August 2017
Edition: 1

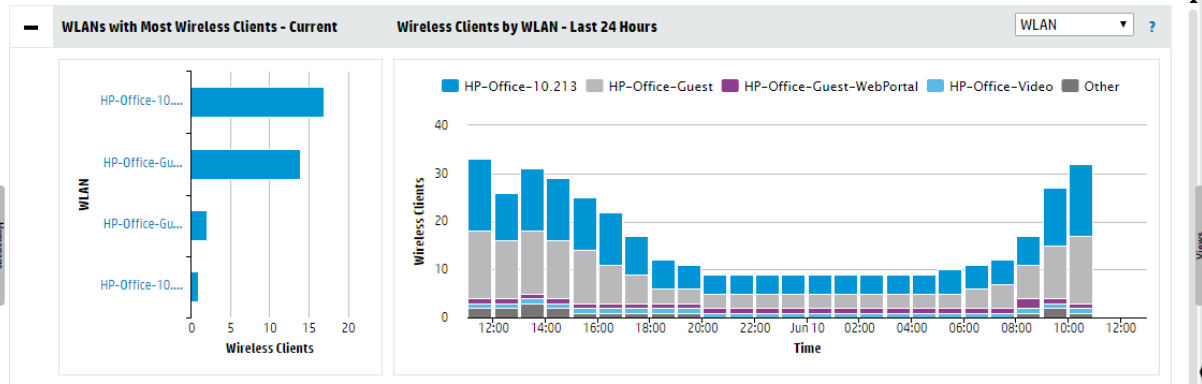
- **Dashboard:** Displays status information about the controller, APs, and wireless clients.

Wireless Clients Current: 34, Peak: 38, Avg: 17			Access Points Online: 11, Offline: 0, Admin Down: 0			Access Points Utilization <50%: 11, 50% - 80%: 0, >80%: 0			Alarms Total: 12, Critical: 0, Major: 0, Minor: 12			
---	--	--	---	--	--	---	--	--	--	--	--	--

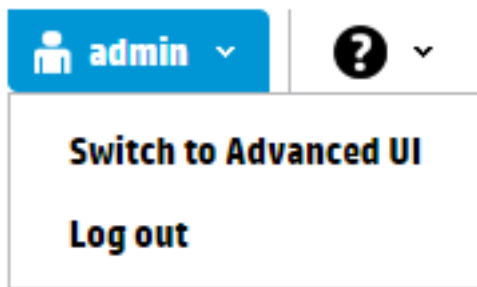
To switch back to the Advanced UI

- Click the administrator icon in the title bar and select **Switch to Advanced UI**. For example, if you logged in using the default username **admin**:
