HP MSM7xx Controllers Release Notes

v6.0.2.2

HP Part Number: 5998-5069
Published: May 2014
Edition: 2

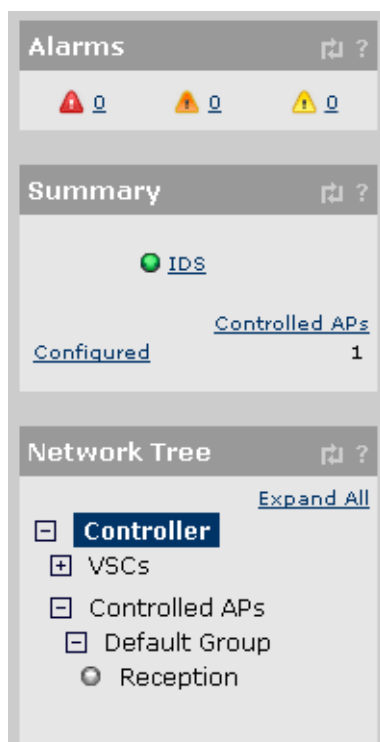
Changes to the left pane

- An **Alarms** box has been added above the **Summary** box.
- The **Summary** box now includes status information for the new IDS feature.
