HP MSM7xx Controllers Release Notes

v6.4.0.0

HP Part Number: 5998-5810
Published: May 2014
Edition: 1

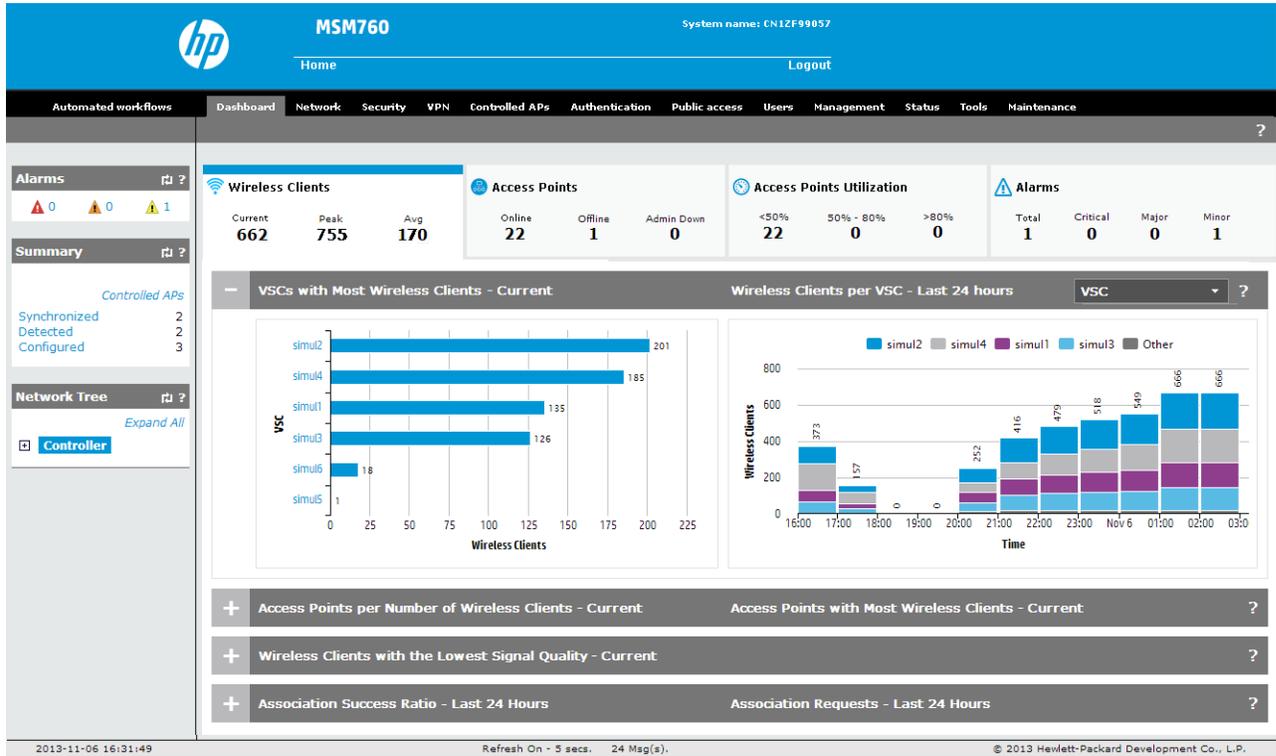
This release includes a new dashboard feature that provides network administrators with a quick way to view key information about the wireless network operation. It uses charts and graphs to display status and statistics, and shows 24-hour history for a number of items.

To view the dashboard, select **Controller >> Dashboard**.

Dashboard groups information into four categories. The top of each tab provides summary statistics for each category.

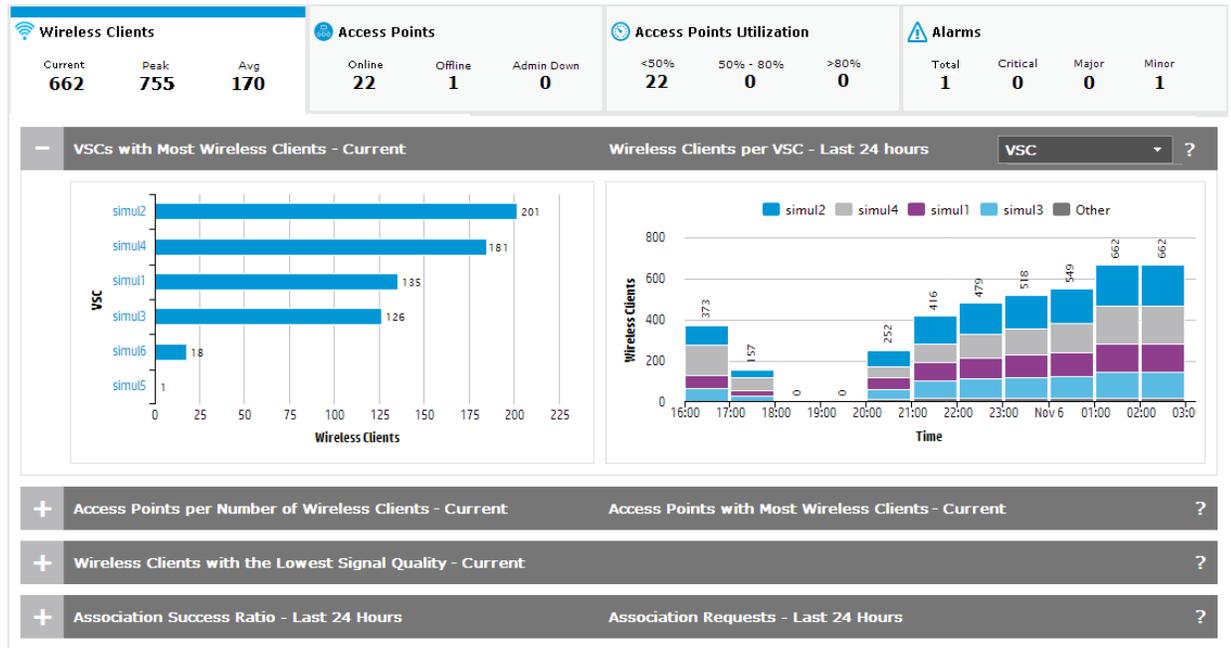
- **Wireless Clients:** Provides information about the wireless clients connected to all controlled APs. For example:

The tab title indicates the number of wireless clients in each of the following categories:

- **Current:** Total number of wireless clients that are currently connected.
- **Peak:** Maximum number of wireless clients that were connected during the last 24 hours.
- **Avg:** Average number of wireless clients that were connected during the last 24 hours.

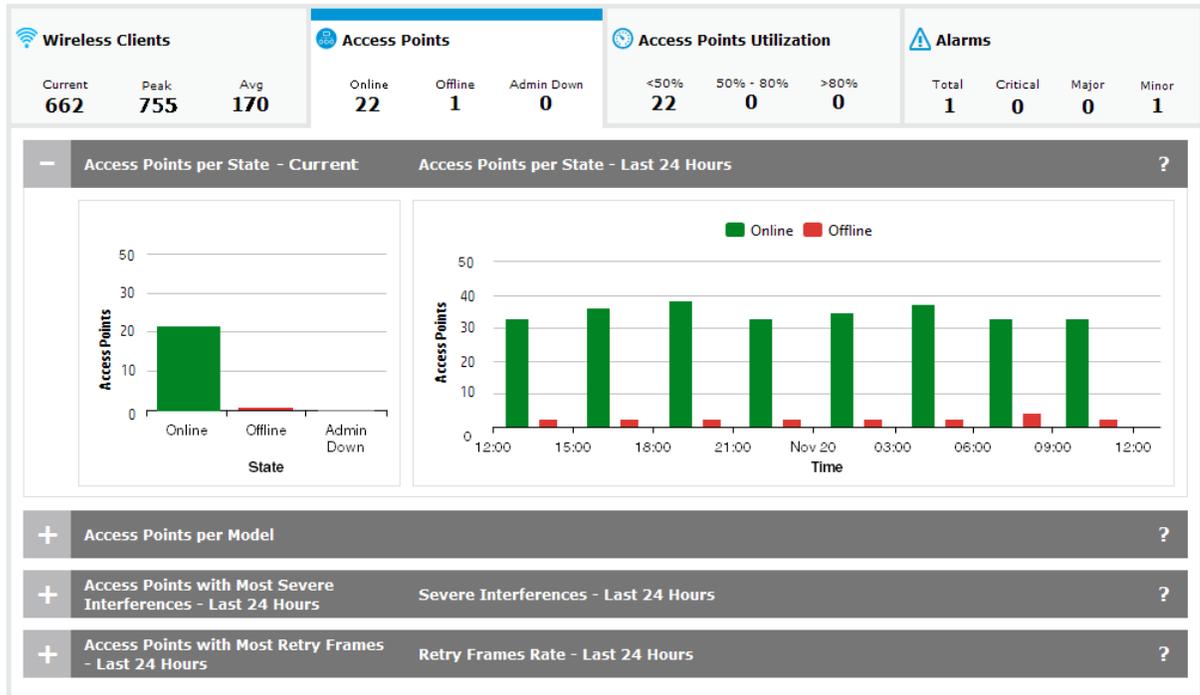
- **Access Points:** Provides information about all controlled APs. For example:

The tab title indicates the number of APs in each of the following states:

- **Online:** The number of APs that are able to exchange management information with the controller.
- **Offline:** The number of APs that have stopped sending management information to the controller. Rediscovery might re-establish the connection. If not, the APs might have lost power or a network failure has occurred. The APs will have a diagnostic value of **Not responding** on the **Controller >> Controlled APs > Discovered APs** page. APs that are flagged as **Admin Down** do not appear in this count.
- **Admin Down:** The number of APs that are **Offline** and have been manually set to **Admin Down** (Administratively Down) by an administrator. This state is used to flag an AP that is known to be offline. For example, for maintenance or relocation.

A new parameter, called Admin Down, has been added. This parameter can be used to flag an AP that is offline for a known reason (such as maintenance or relocation) to differentiate it from other APs that are offline for unknown reasons (network failure, power failure, or other issues that prevent them from communicating with the controller).

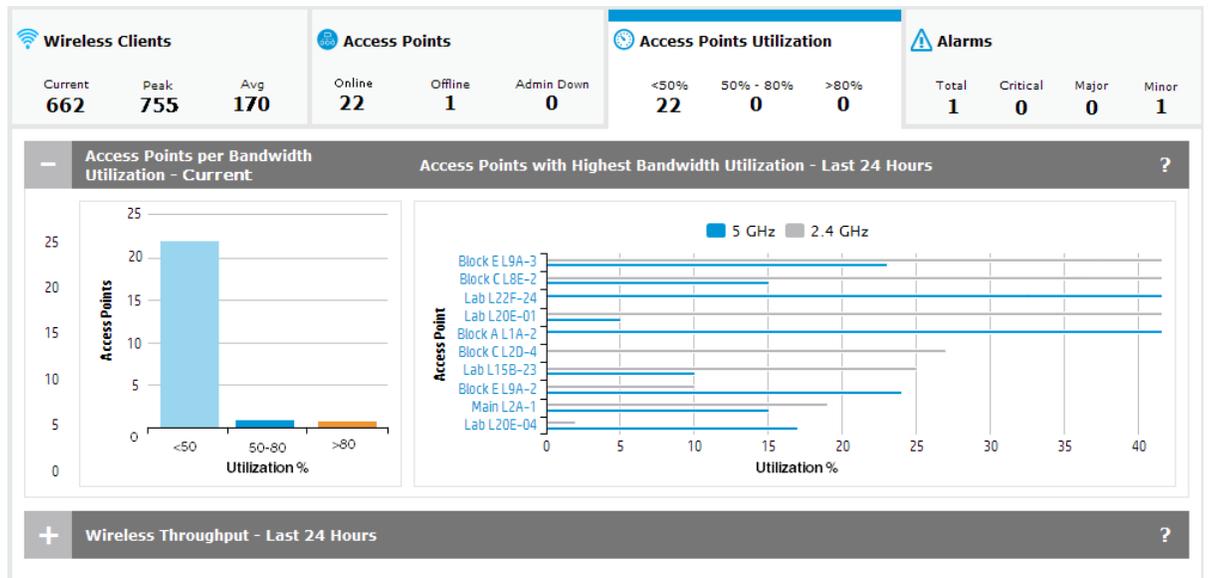
- **Access Points Utilization:** Information about the utilization of controlled APs. For example:

The tab title displays the number of APs currently operating in each bandwidth utilization range: <50%, 50% - 80%, >80%. The percent utilization is calculated by comparing the total throughput (transmitted/received) of all radios on an AP for the last minute against the maximum throughput that the radios could theoretically achieve. (Only *online* APs with radios that are enabled and operating in *access point* and/or *local mesh* mode are included.)

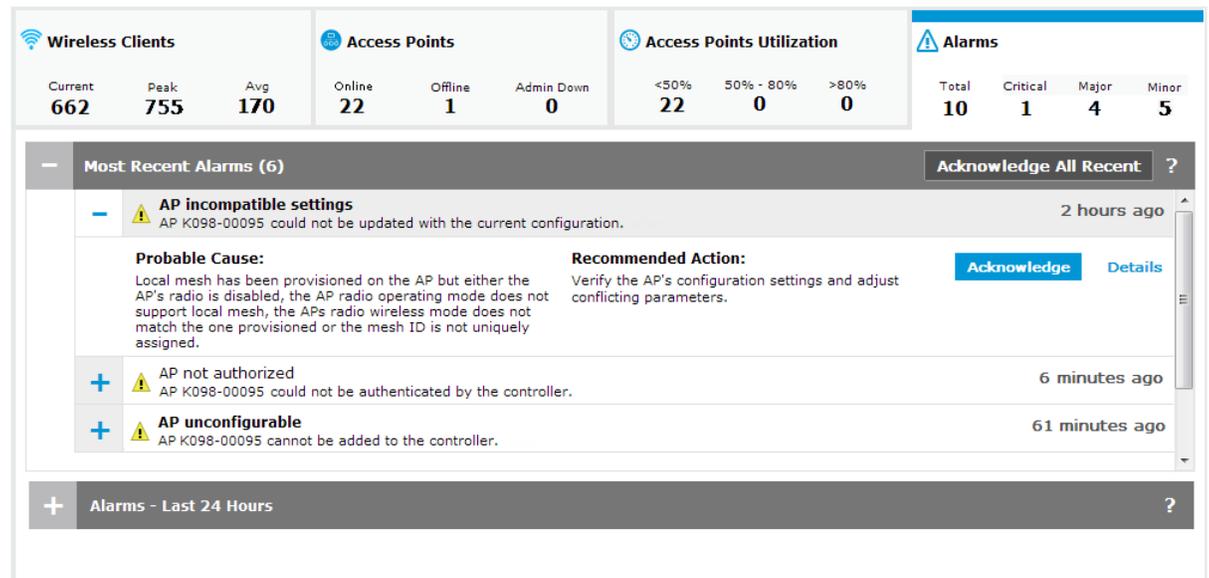
- **Alarms:** A summary of all active alarms. For example:

The tab title displays the total number of active alarms for each severity.
