HP MSM7xx Controllers Release Notes

v6.4.1.0

HP Part Number: 5998-6545
Published: August 2014
Edition: 1

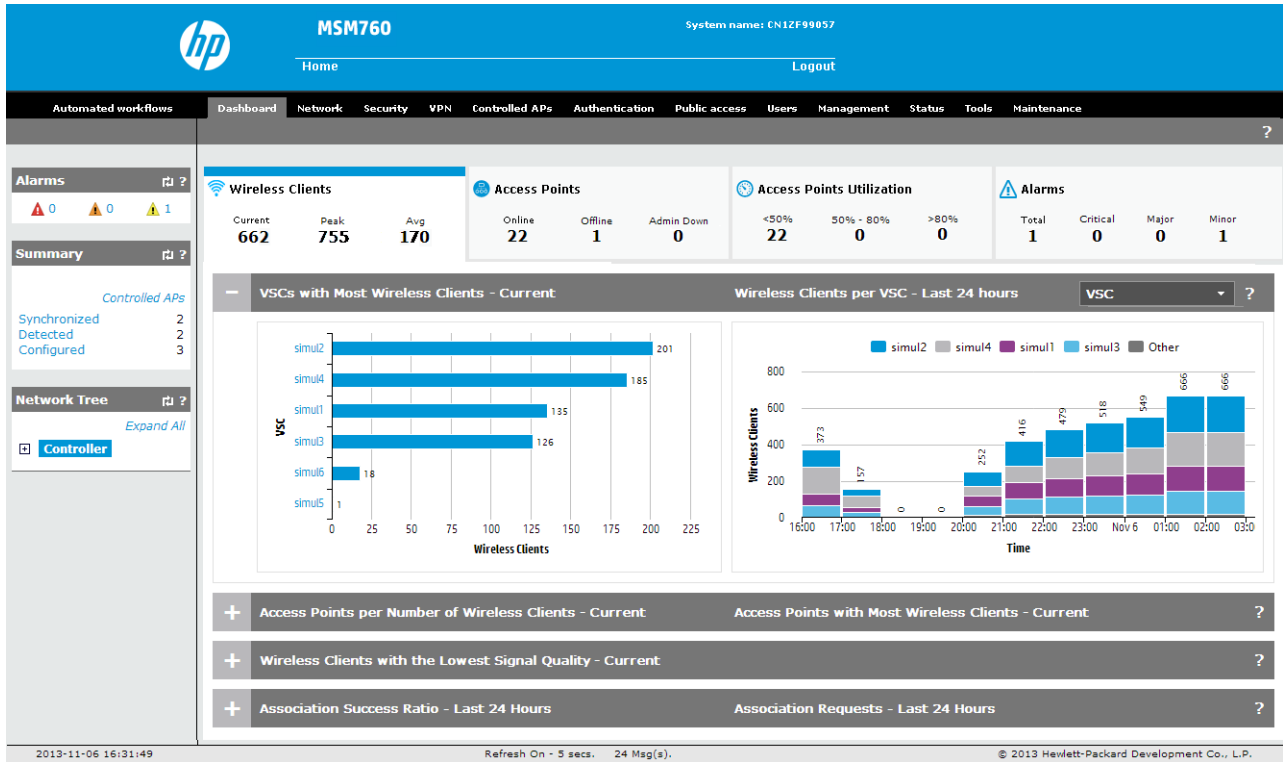
This release includes a new dashboard feature that provides network administrators with a quick way to view key information about the wireless network operation. It uses charts and graphs to display status and statistics, and shows 24-hour history for a number of items.

To view the dashboard, select **Controller >> Dashboard**.

Dashboard groups information into four categories. The top of each tab provides summary statistics for each category.

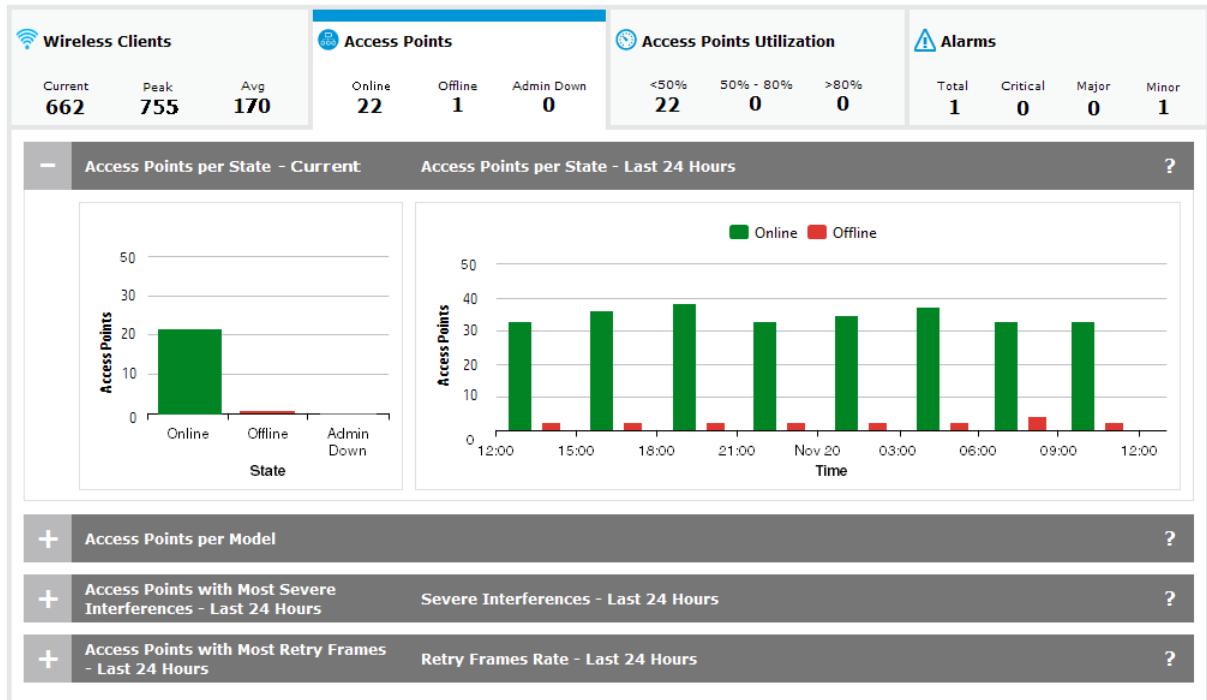
- **Access Points:** Provides information about all controlled APs. For example:

The tab title indicates the number of APs in each of the following states:

- **Online:** The number of APs that are able to exchange management information with the controller.
- **Offline:** The number of APs that have stopped sending management information to the controller. Rediscovery might re-establish the connection. If not, the APs might have lost power or a network failure has occurred. The APs will have a diagnostic value of **Not responding** on the **Controller >> Controlled APs > Discovered APs** page. APs that are flagged as **Admin Down** do not appear in this count.
- **Admin Down:** The number of APs that are **Offline** and have been manually set to **Admin Down** (Administratively Down) by an administrator. This state is used to flag an AP that is known to be offline. For example, for maintenance or relocation.

A new parameter, called Admin Down, has been added. This parameter can be used to flag an AP that is offline for a known reason (such as maintenance or relocation) to differentiate it from other APs that are offline for unknown reasons (network failure, power failure, or other issues that prevent them from communicating with the controller).

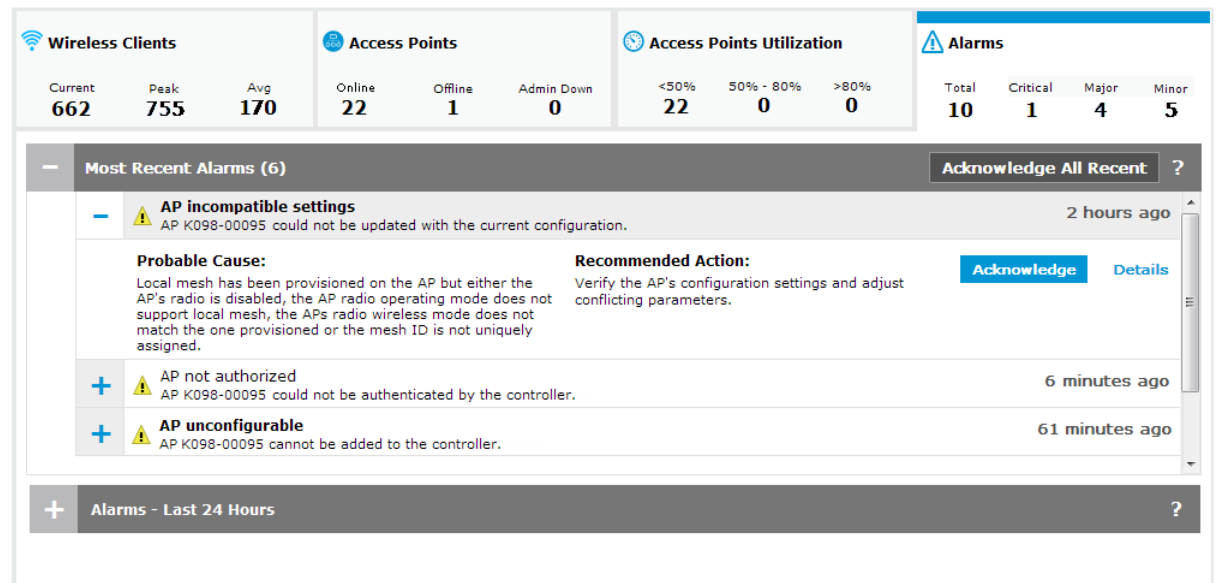
- **Alarms:** A summary of all active alarms. For example:

The tab title displays the total number of active alarms for each severity.
